DOT/FAA/RD-94/22

①
**Composite Helicopter
Accident Profiles -
Deficient Crew/Aircraft
Performance**

Final Report

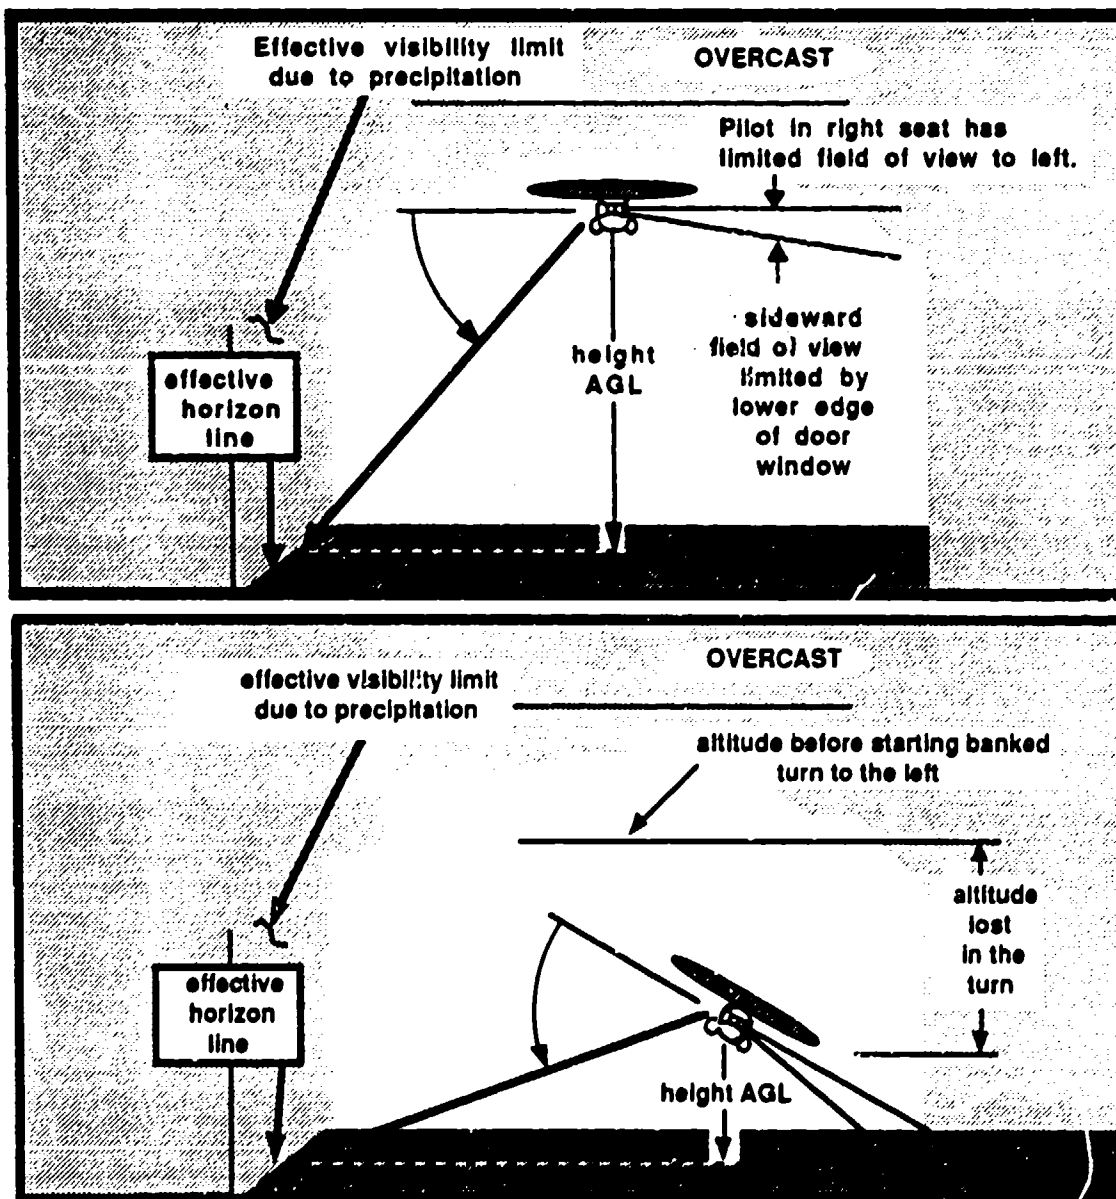
The turn was to the blind side. The pilot was in the right seat. The pilot was not attempting to fly eyes-in and eyes-out during the turn. Although there is a common tendency to turn into the blind side, there is no ready explanation for this preference other than a pilot can keep the instrument panel in his field-of-view while alternately scanning over the panel and out the left door window for spatial references and obstructions. There is a possibility that, failing to see cues over the nose, the cues out the right window were the only ones available. When the pilot rolled into a left bank (in this case), the horizon cues out the left window may have been blocked by the upper door frame and cabin roof. The cues out the right window may have disappeared below the right side window frame. This total loss of peripheral depth cues could explain the pilot's failure to recognize the descent during the turn. This loss of cues might even induce a pilot to fly lower in an attempt to regain the cue line on the right side (see figure 7-6).

FIGURE 7-6. HORIZON CUES ARE ALSO AVAILABLE OUT THE SIDE WINDOW

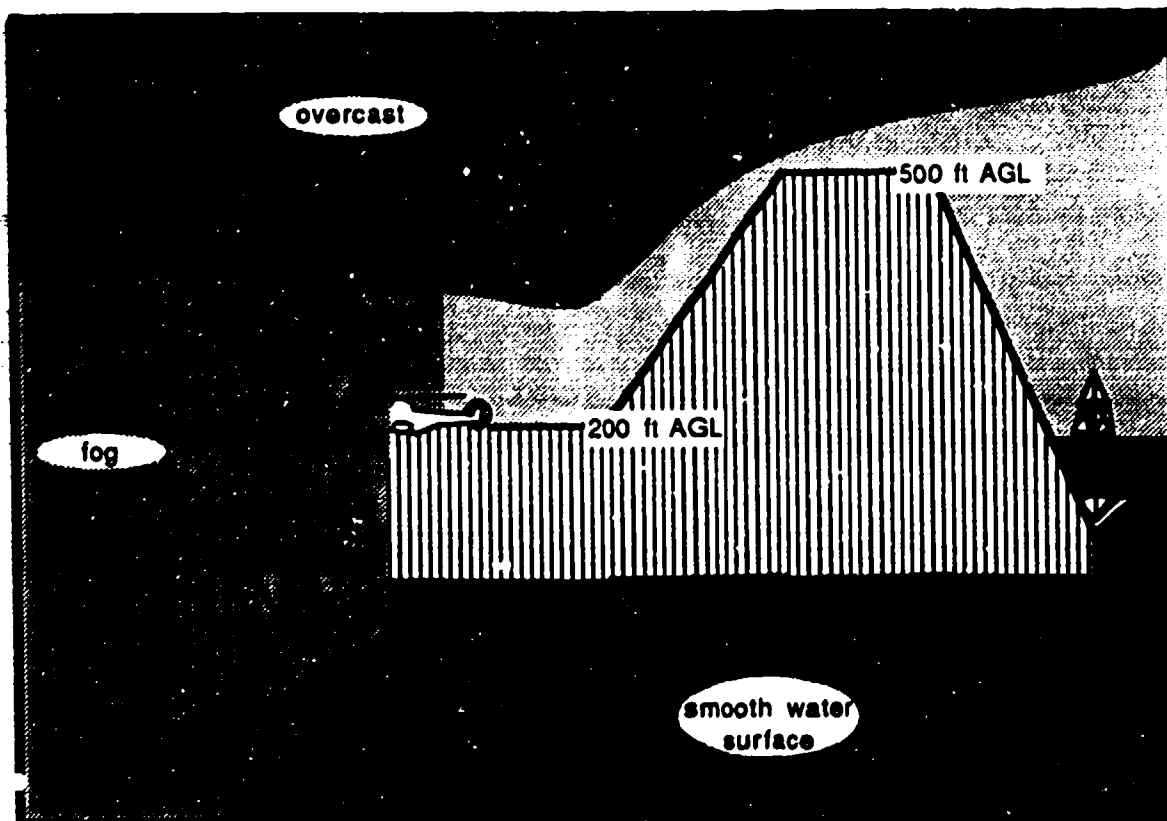
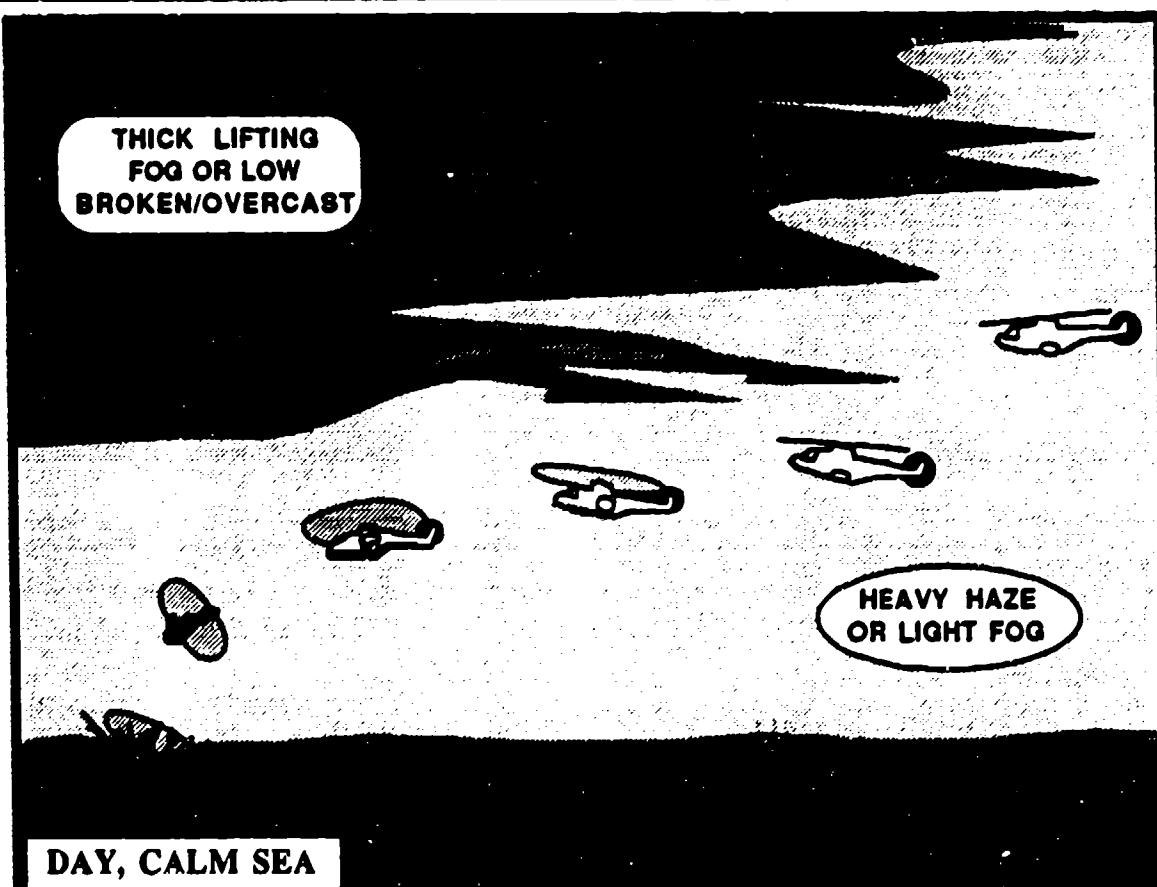
FIGURE 7-7. DESCENDING, DECELERATING TURN IN FOG OVERWATER, TURNING, INADVERTENT DESCENT SCENARIO (7C)

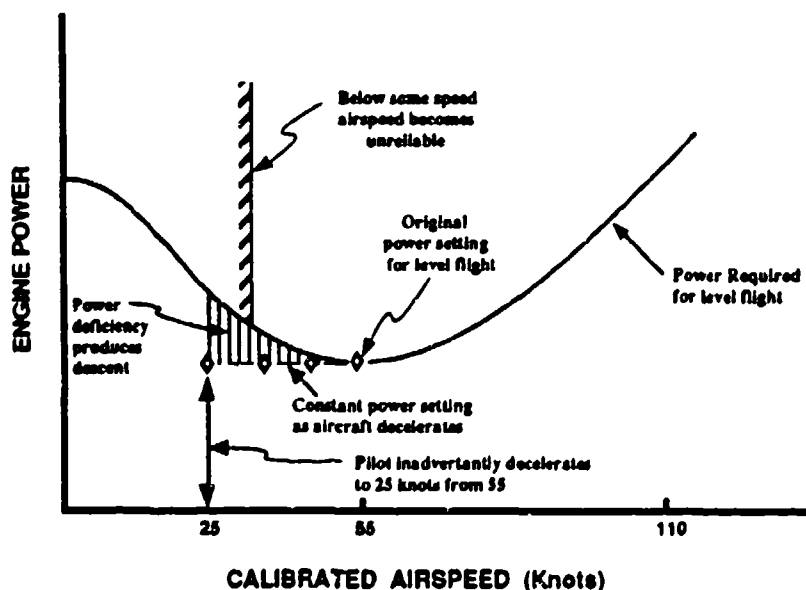
The first question involves the descent. If the pilot had set the power for minimum speed and continued to decelerate, the aircraft would descend because the power would be inadequate for constant altitude flight (figure 7-8). The fact that the aircraft was in a banked turn would tend to increase this descent. The pilot was splitting his attention between looking out into the turn, and looking in, to check the operation of the aircraft. At some point, the pilot observed a high rate of descent and reported some difficulty in the control task. The airspeed was now observed to have become unreliable. This is interpreted as meaning that the airspeed pointer was flopping around. This airspeed indication suggests that the aircraft had slowed to some speed below 25 to 30 knots, maybe even to zero. As figure 7-8 would suggest, a rapid sink rate could easily develop as a result of inattention to power during the deceleration. The reported control difficulty is symptomatic of slow speed control coupling and the loss of static directional stability which typically occurs below 30 knots. The control difficulty would normally cause the pilot to re-direct his attention back into the cockpit. The pilot was probably looking in the cockpit, attempting to increase power and arrest the descent, when the aircraft struck the water at a slow forward speed.

FIGURE 7-8. DESCENT AS THE RESULT OF A CONSTANT POWER DECELERATION
Some airplanes have adequate natural stall warning; others are equipped with stall warning systems which alert the pilot that the aircraft is decelerating to a dangerously

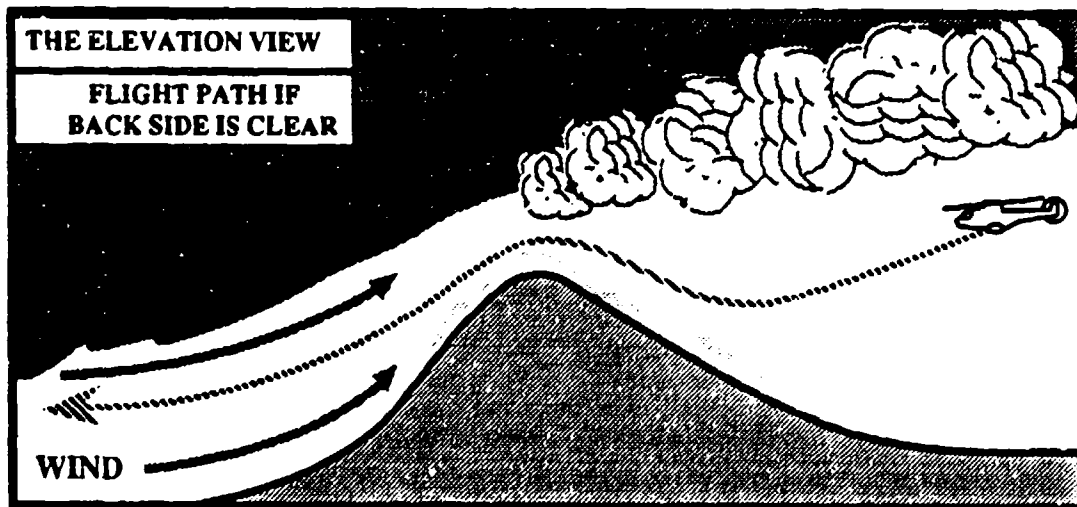
It is interesting to note that the weather was bad on the far side of the ridge in every event analyzed. This suggests that a low pass near the crest of a ridge line to check the weather is simply a bad idea and should be avoided.

FIGURE 7-9. PLANNED ROUTE OVER RIDGE

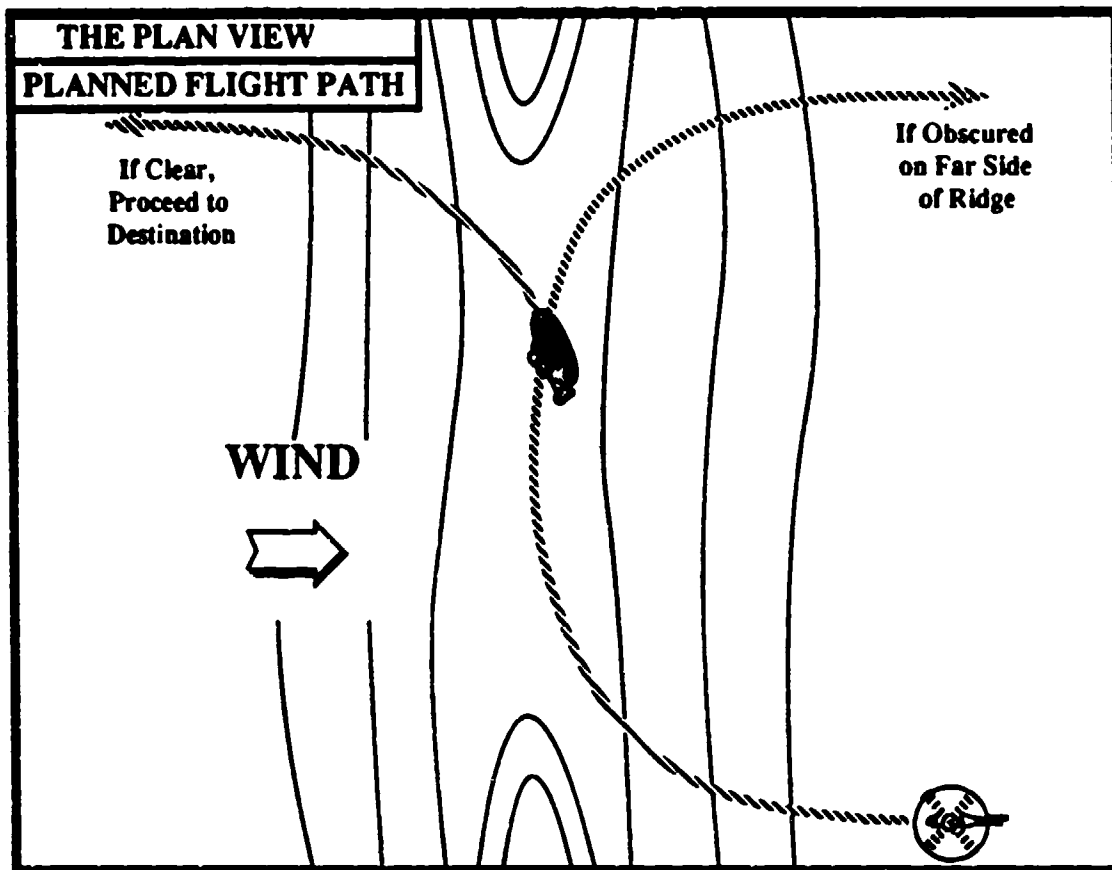
FIGURE 7-10. PLAN TO CONDUCT ROUTE-WEATHER RECONNAISSANCE

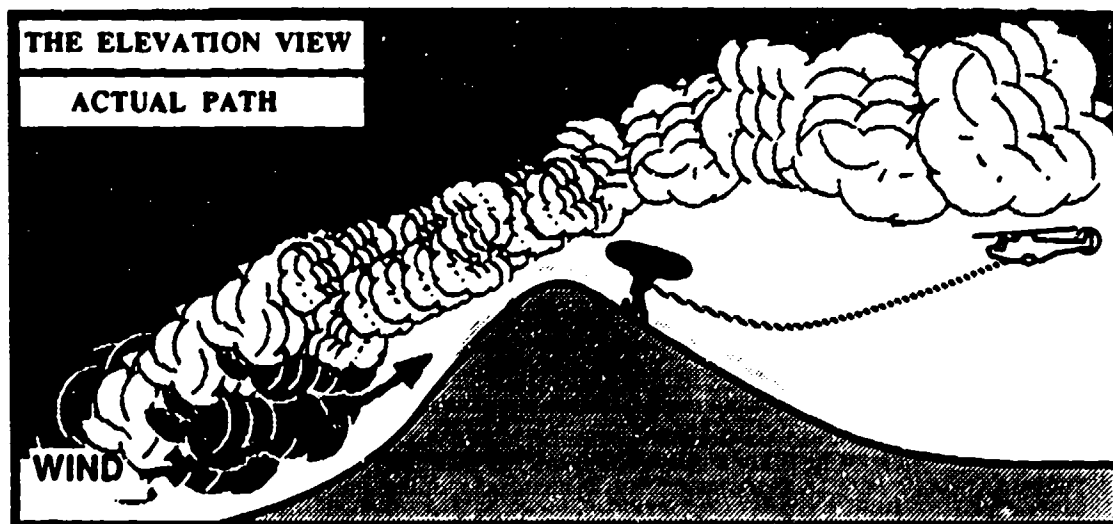
FIGURE 7-11. ROUTE-WEATHER RECONNAISSANCE ENDS IN TERRAIN STRIKE

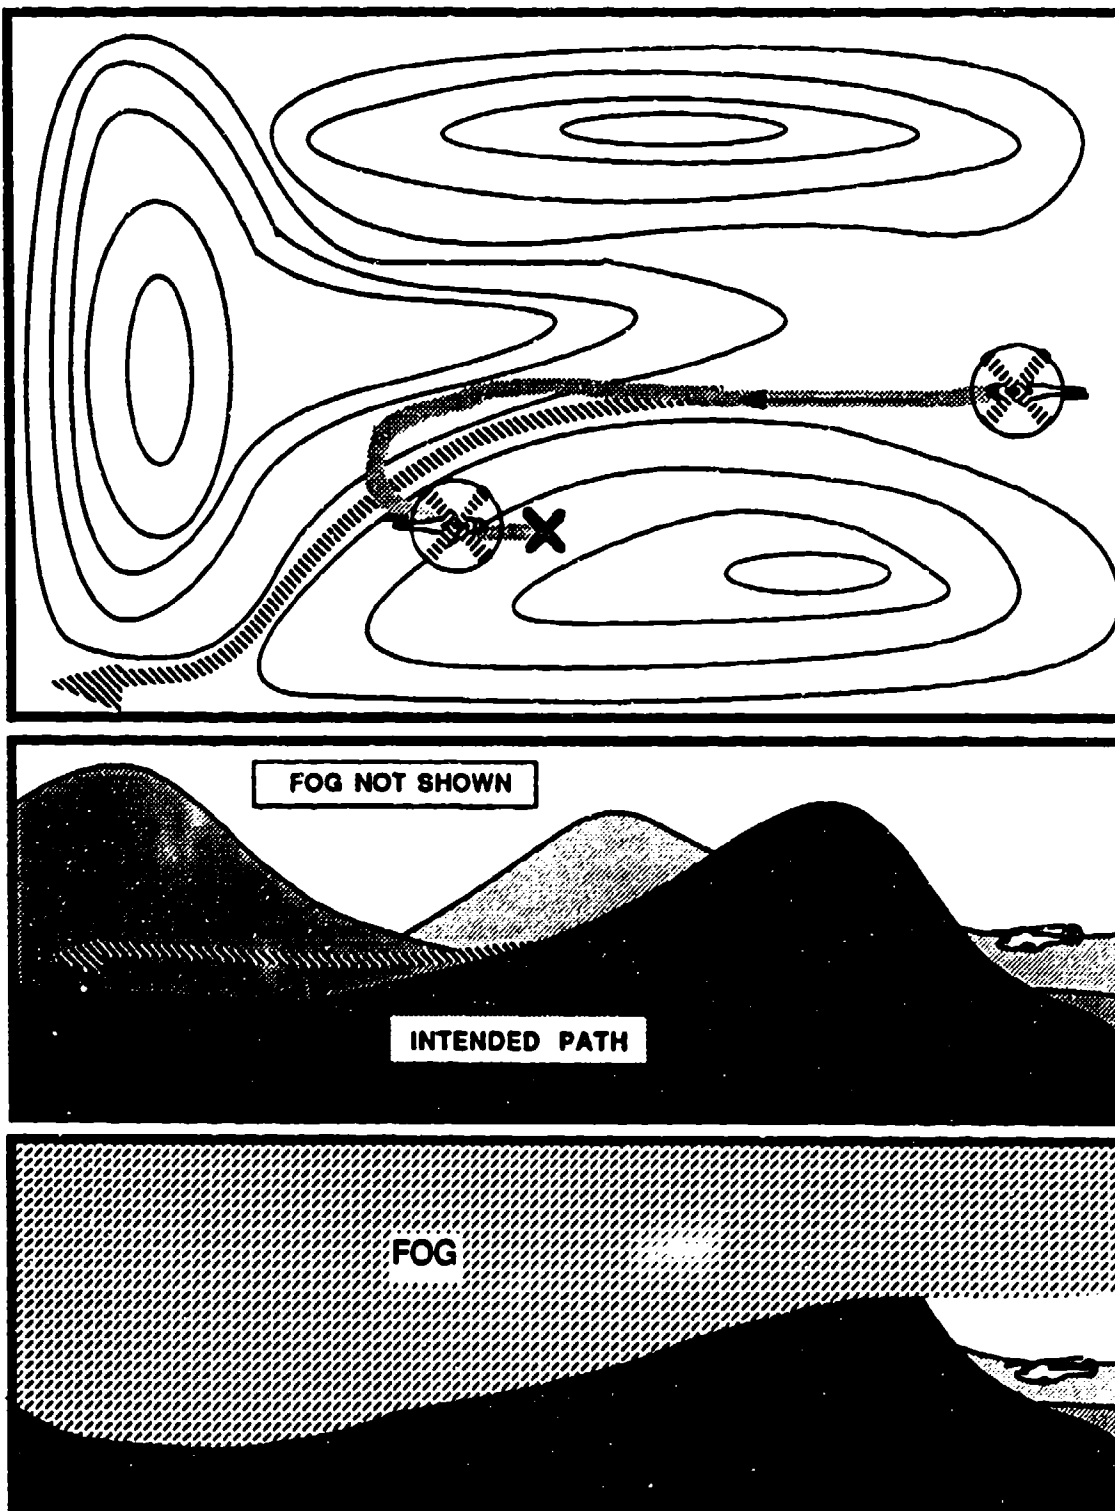
At slow speeds, an uncompensated collective input causes the aircraft to yaw into a side-slip condition. The aircraft will tend to roll and pitch as the side-slip builds. The pilot must now compensate with longitudinal and lateral control displacements to keep the aircraft level.

FIGURE 7-12. REVERSE COURSE INTO UP-SLOPE

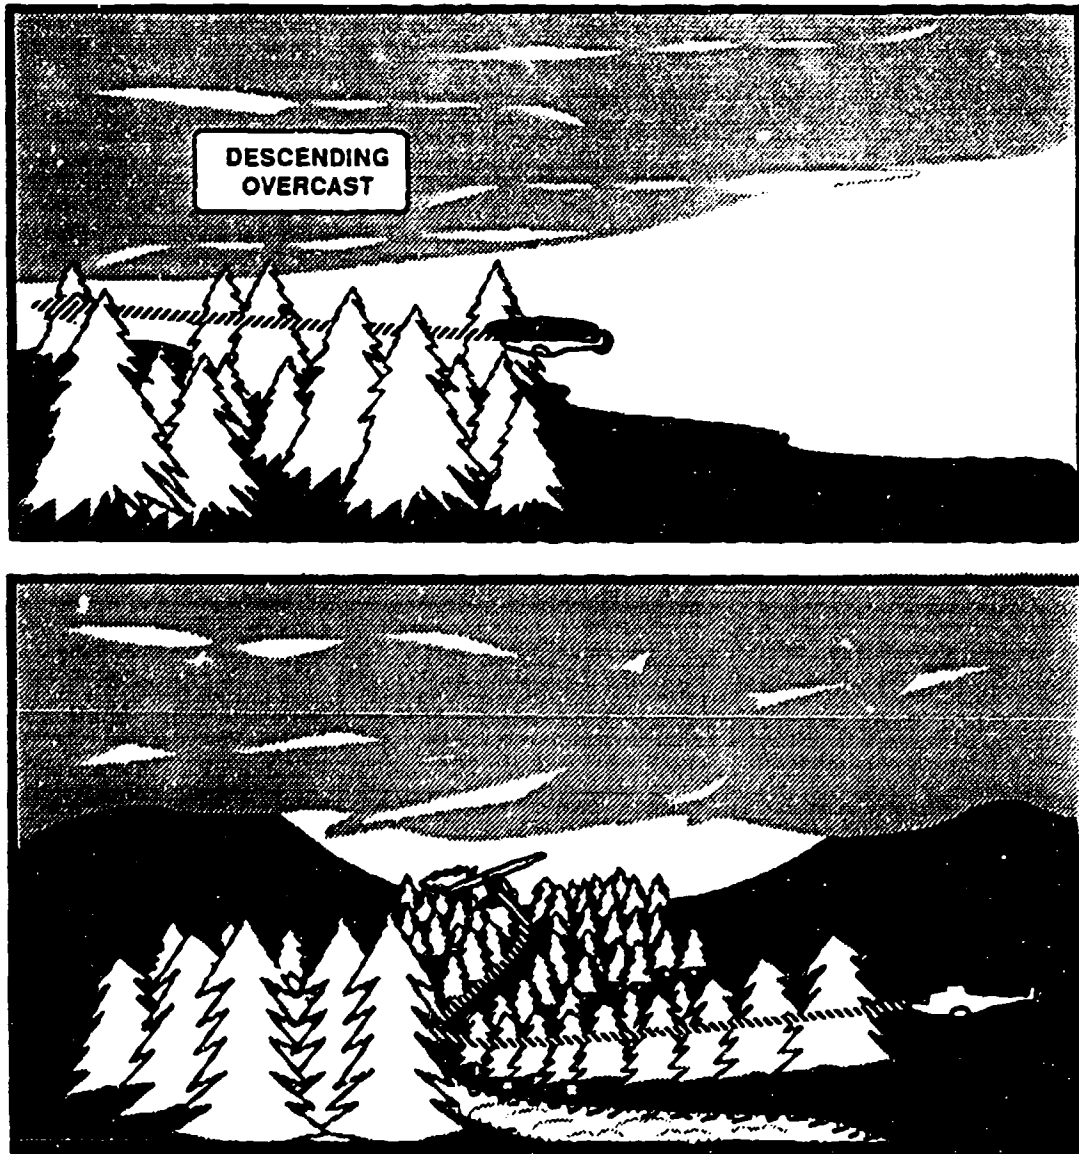
FIGURE 7-13. CONTINUED FLIGHT DEEP IN MICRO TERRAIN

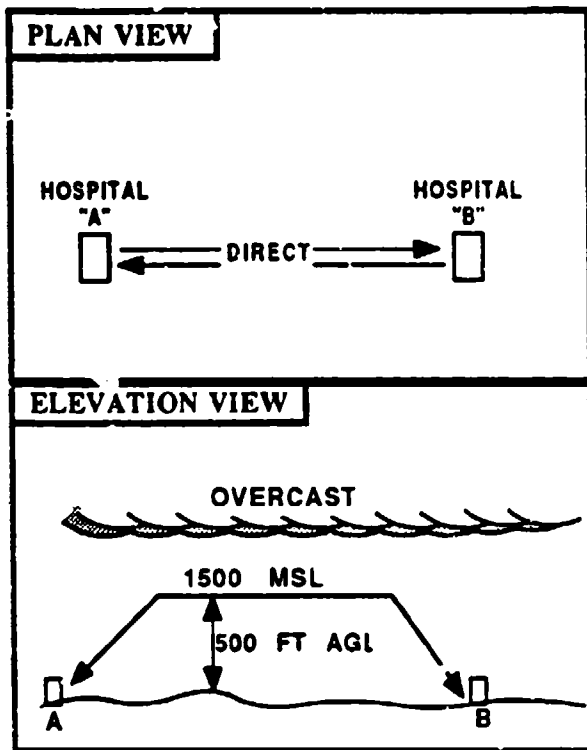
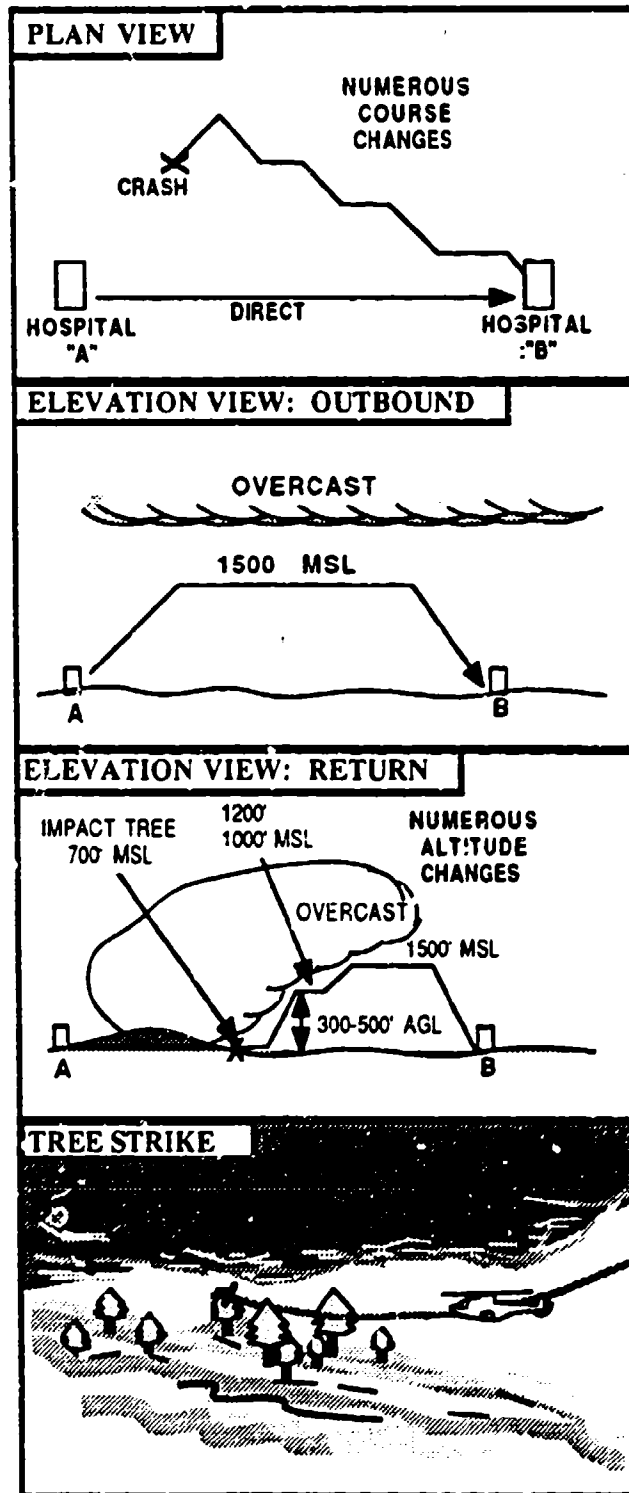
FLIGHT AS PLANNED

FLIGHT AS FLOWN

FIGURE 8-1. EN ROUTE, DIRECT (NIGHT) SCENARIO

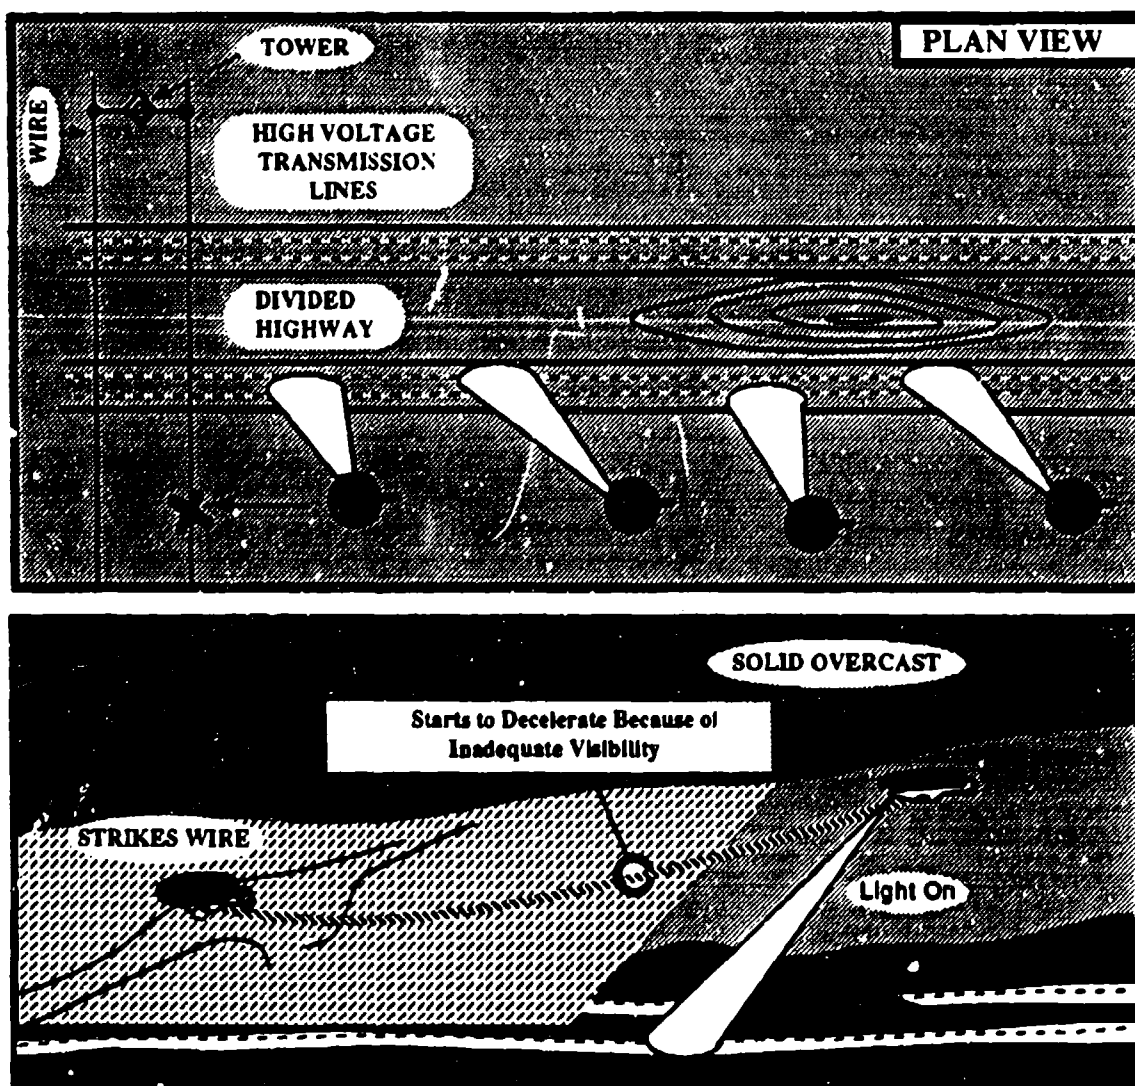
FIGURE 8-2. ROAD FOLLOWING (NIGHT) SCENARIO

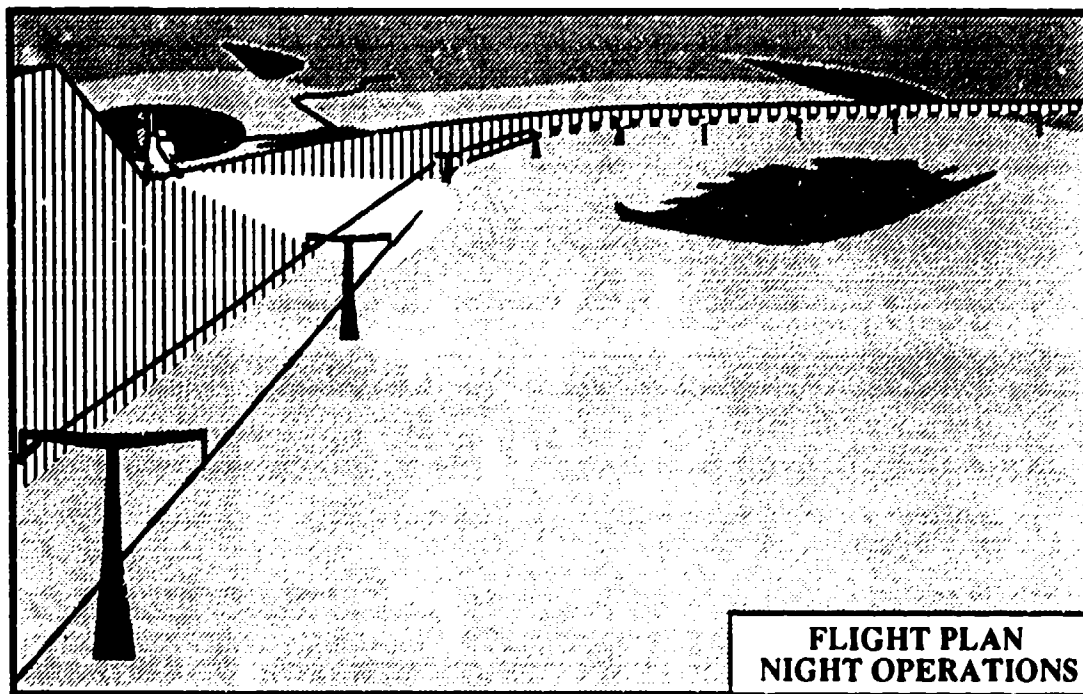
FIGURE 8-3. POWER LINE FOLLOWING (NIGHT) SCENARIO

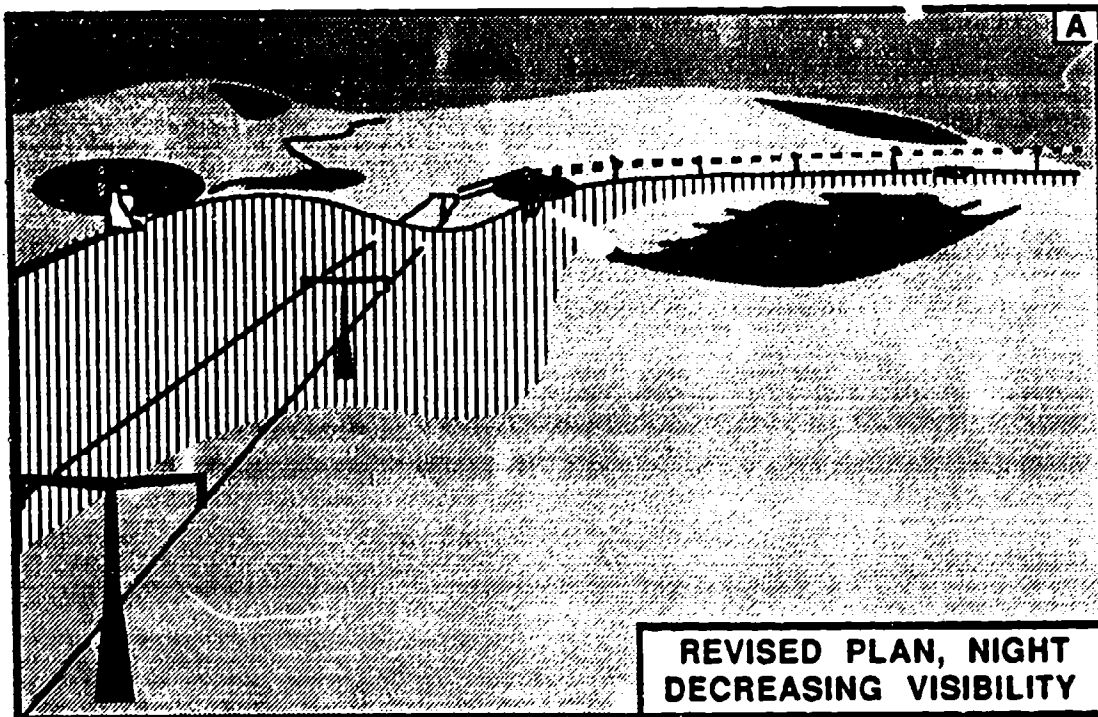
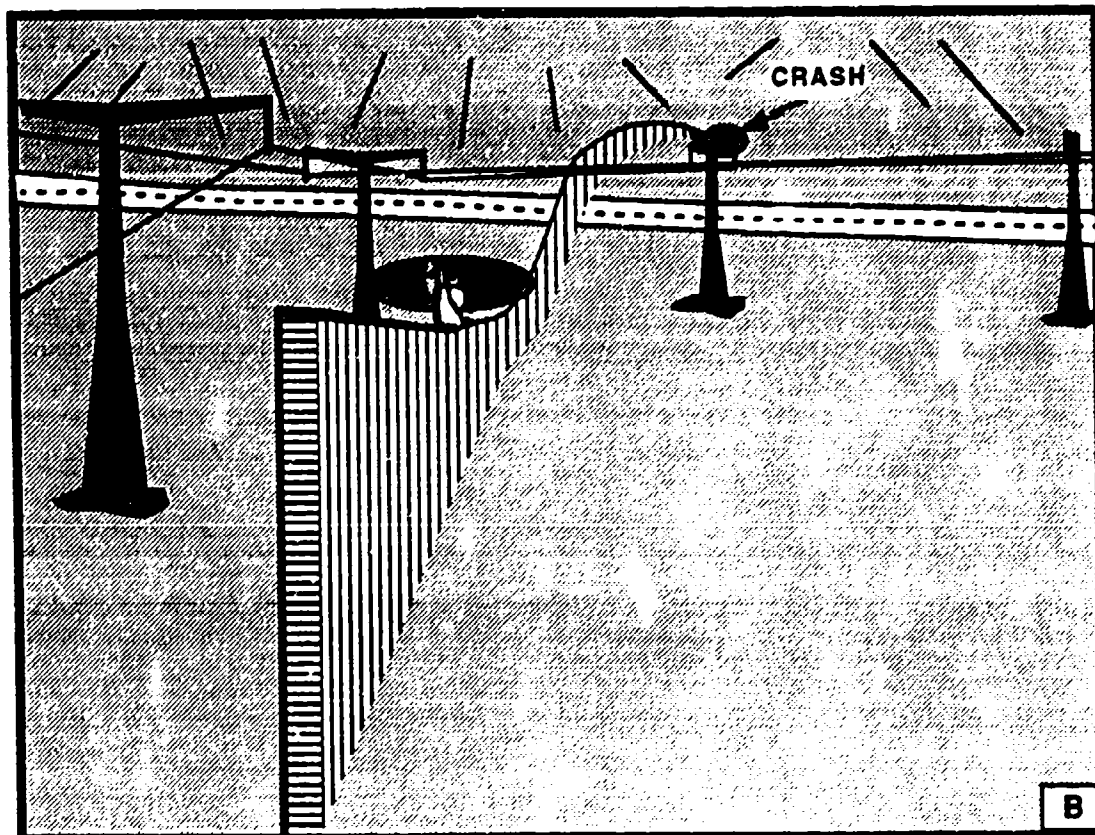
FIGURE 8-4. POWER LINE FOLLOWING (NIGHT) SCENARIO
(CONTINUATION)

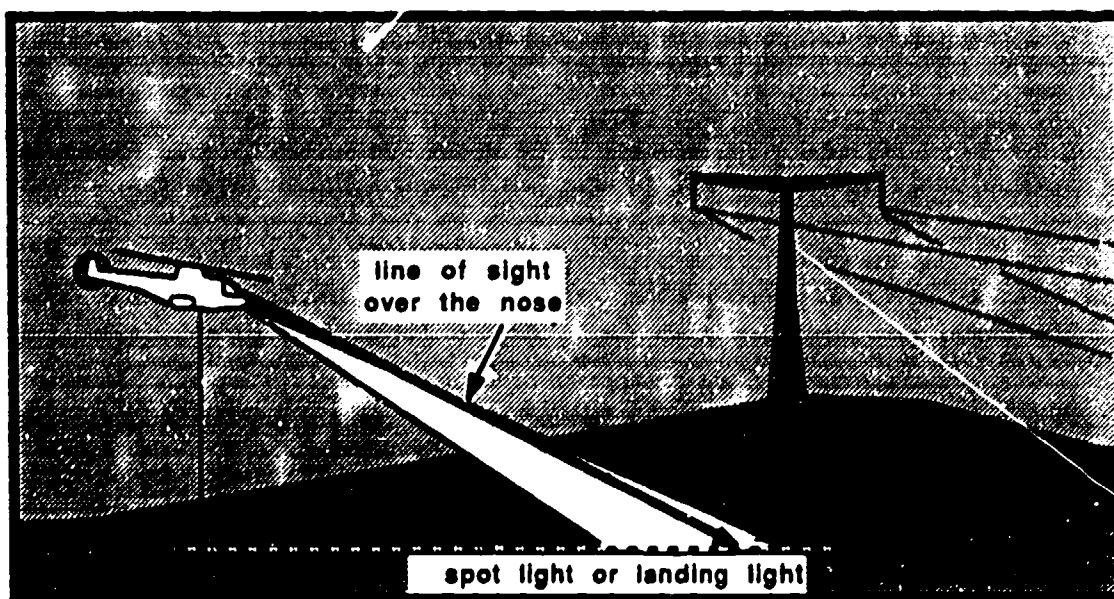
FIGURE 8-5. LIMITATION OF LANDING LIGHTS FOR OBSTRUCTION DETECTION

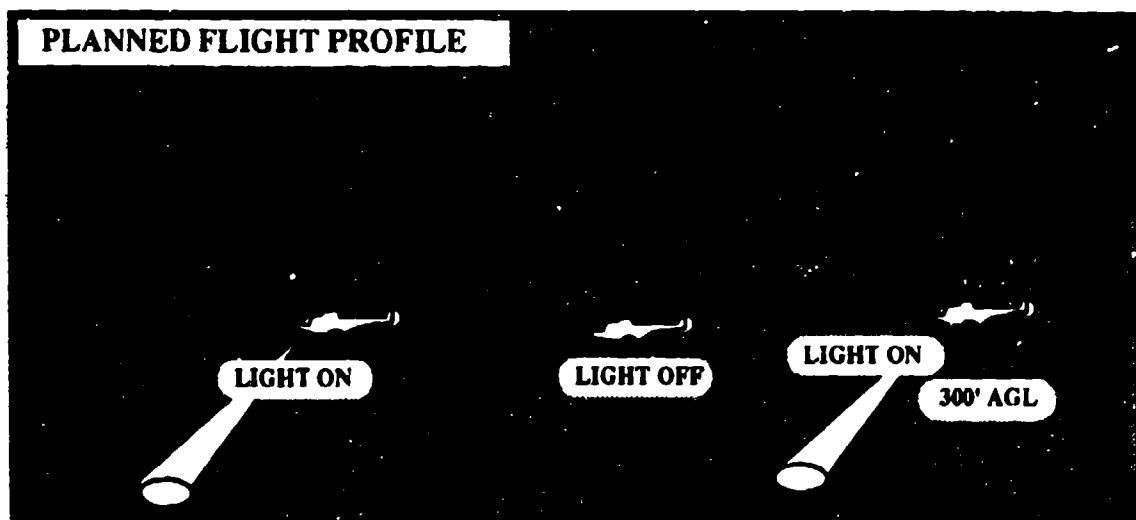
FIGURE 8-6. SLOW SPEED DISORIENTATION (NIGHT) SCENARIO

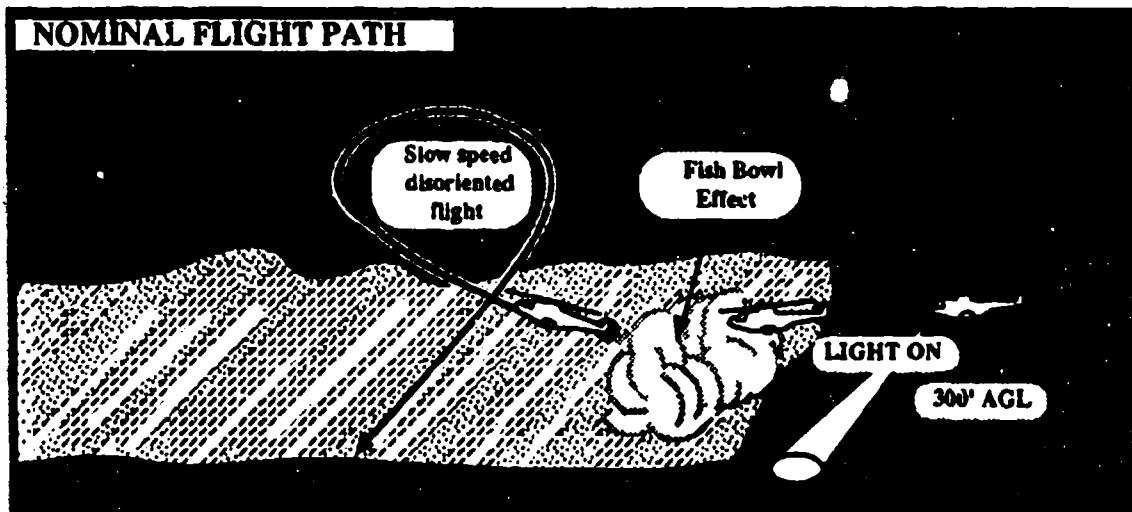
FIGURE 8-7. RECONSTRUCTION OF SLOW SPEED DISORIENTATION (NIGHT) SCENARIO

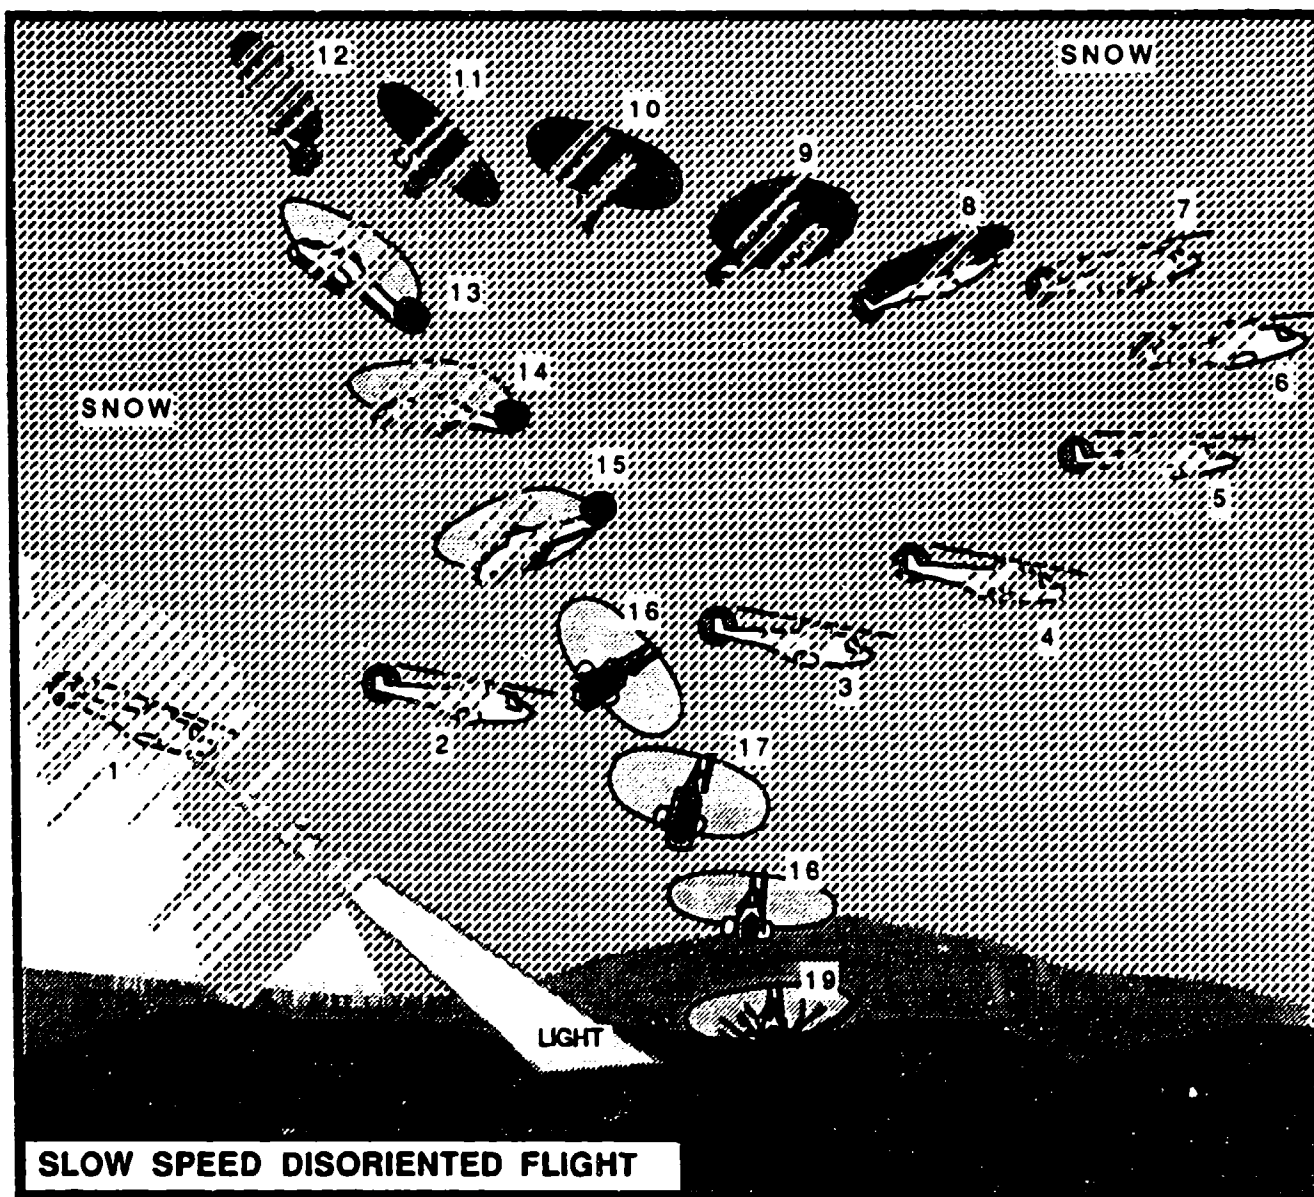
FIGURE 8-8. ANALYSIS OF SLOW SPEED DISORIENTATION

- remained at altitude, above the obstructions, and
- had avoided encounters with IMC conditions.

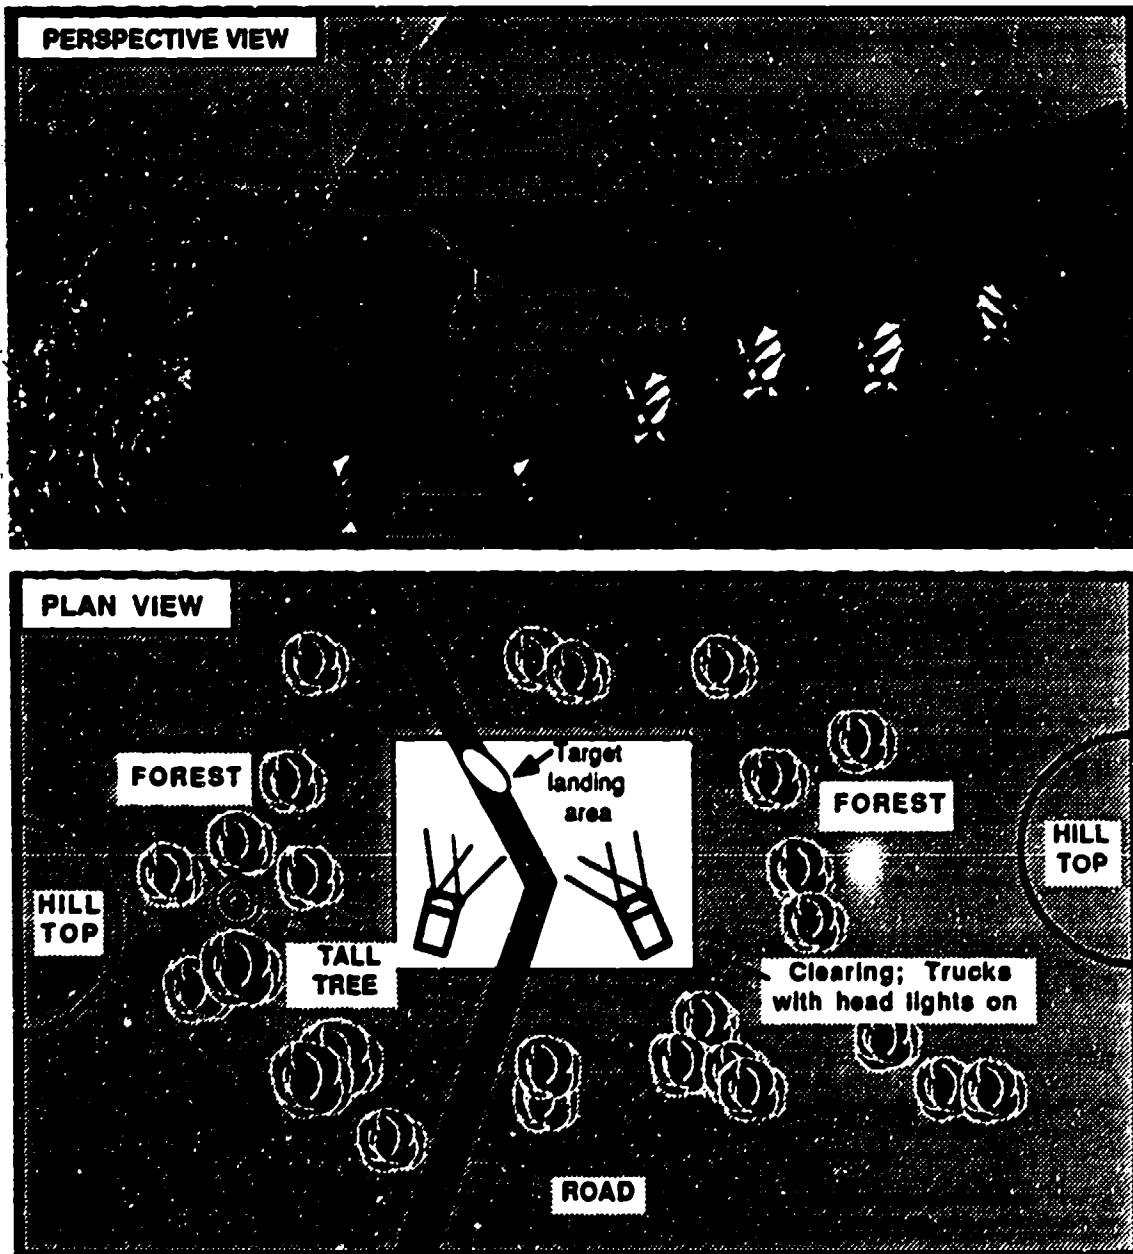
FIGURE 9-1. REMOTE LANDING SITE

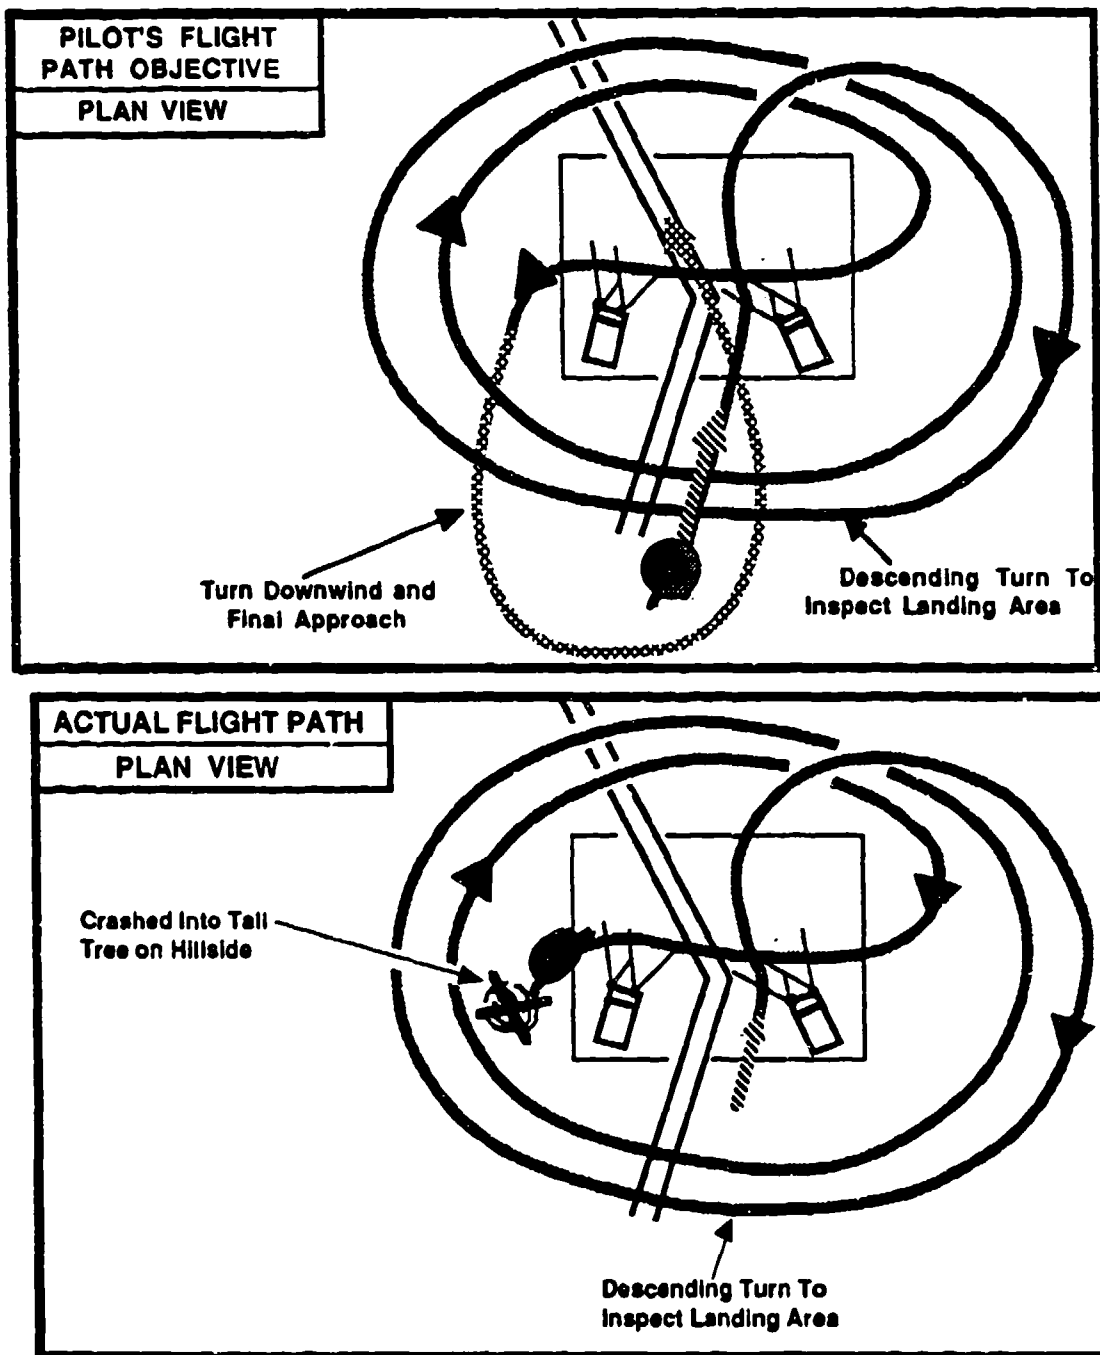
FIGURE 9-2. CIRCLING DESCENDING APPROACH TO COMBINED SITE ANALYSIS

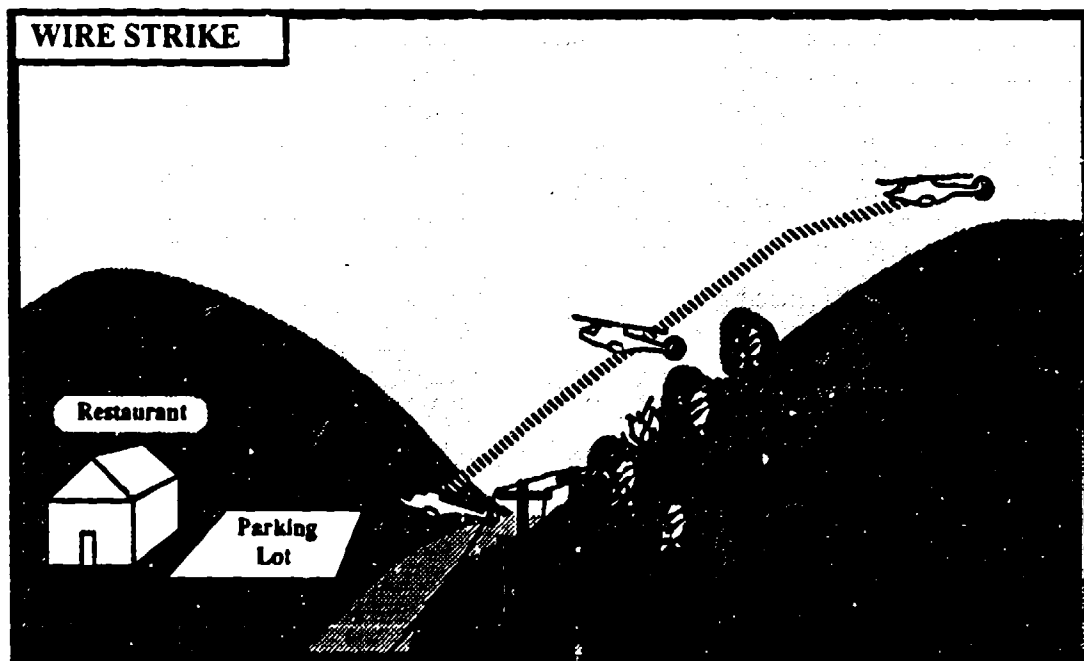
FIGURE 10-1. STEEP APPROACH INTO WIRE ON APPROACH TO CONFINED AREA

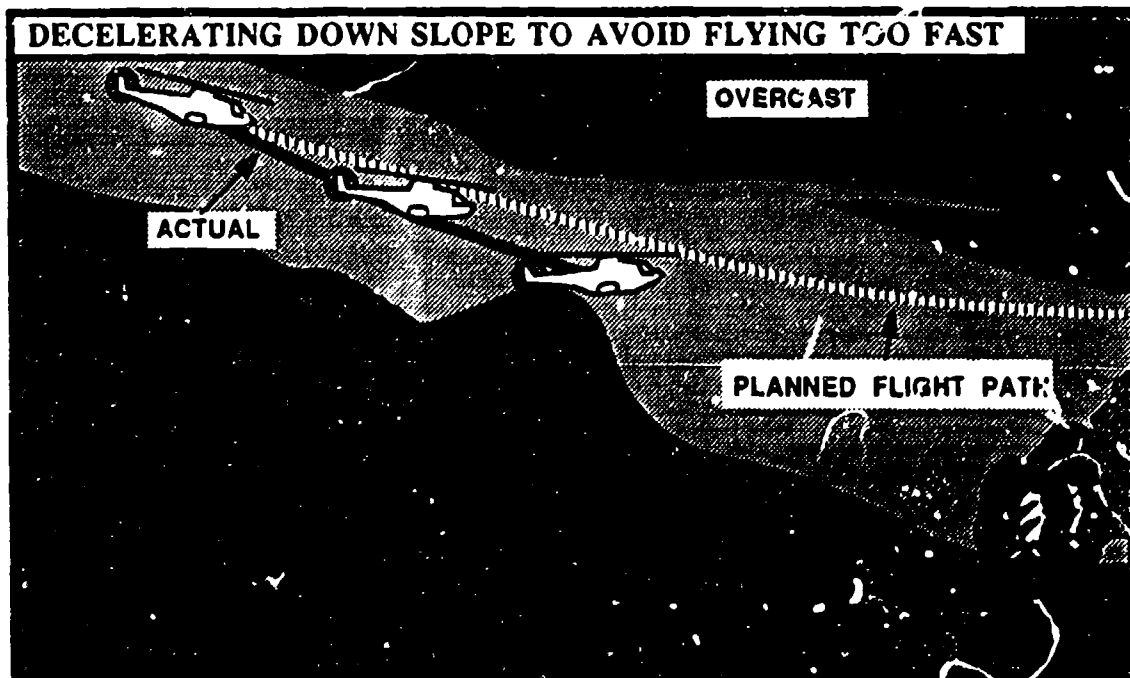
FIGURE 10-2. UNDERSHOOTING INTENDED FLIGHT PATH DURING ATTEMPT TO CONTROL AIRSPEED WHILE FLYING DOWN HILL UNDER OVERCAST
